Metro Home & Property Inspections

Property Inspection Report

Property address: **Deleted For Privacy**
Staten Island, NY 10308

Inspection date: **Saturday, September 29, 2018**

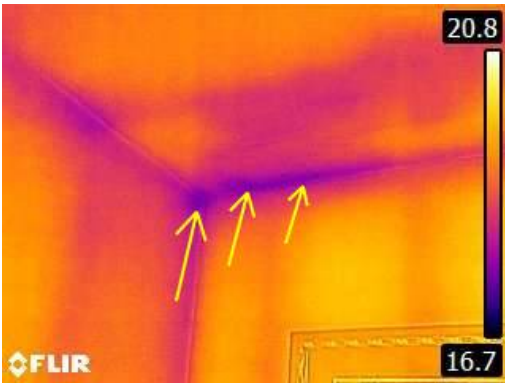
Photo 25-2

Gaps were found in or around roof soffits and can allow birds or vermin to enter the attic and could also be the source of water entering the dining room area corners. Recommend that a qualified person repair as necessary to eliminate gaps.

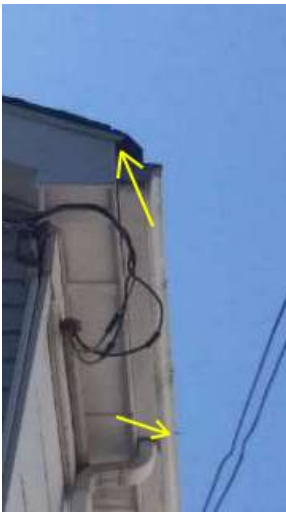
Photo 28-1

28) Gutter on right side of house near the front has a spike that is coming loose and recommend having it repaired before it gets work and loosens the gutter

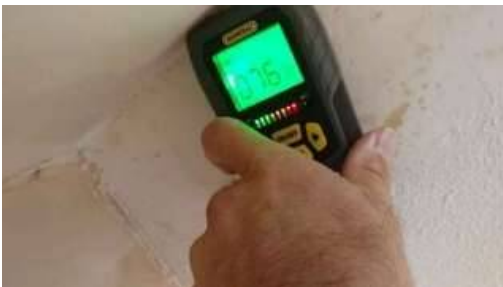
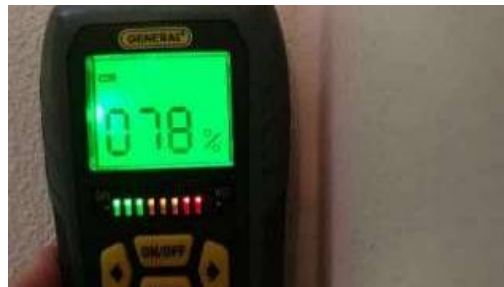
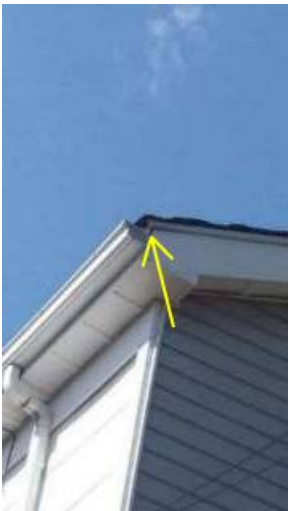
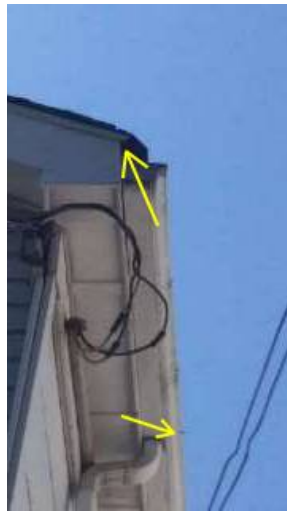
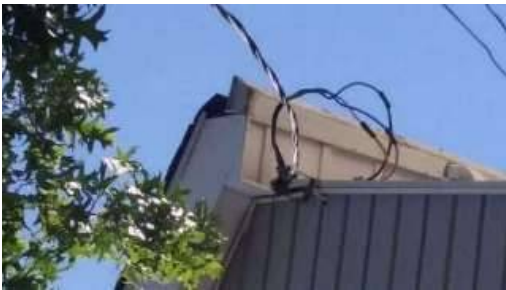
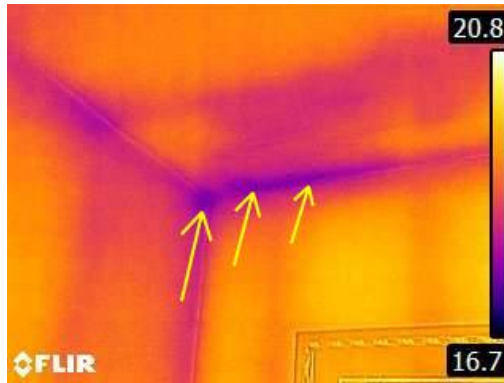
Stains and elevated levels of moisture were found in one or more ceiling areas. The stains appear to be due to an active roof leak. Recommend that a qualified contractor evaluate and repair as necessary.

Leak seems to be entering from where the roof meets gutters. Tiny openings appear that could be allowing water to enter.

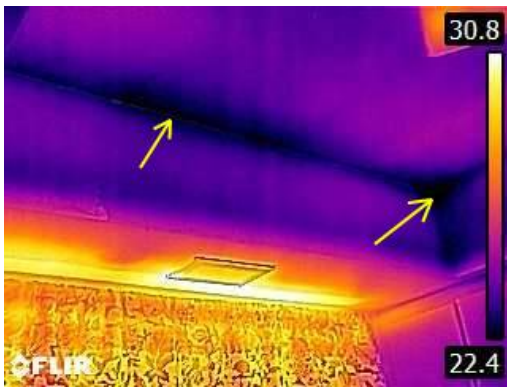
Photo 94-3 Dark sections are moisture

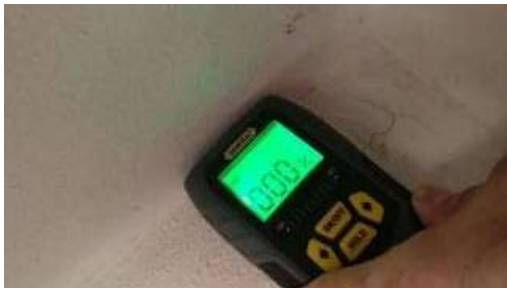
95) Stains were found in one or more ceiling areas, including ceiling in basement bathroom . However, no elevated levels of moisture were found. The stain(s) may be due to past roof and/or plumbing leaks. Consult with the property owner and monitor the stained area(s) in the future, especially after heavy or prolonged rain. If elevated moisture is found in the future, then recommend that a qualified contractor evaluate and repair as necessary.

Photo 95-1 Old water stains - 0 percent moisture

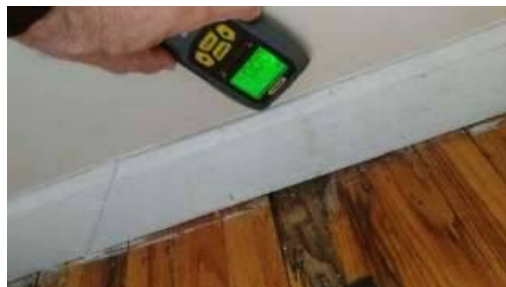
Photo 95-4 Very Dry - no active water

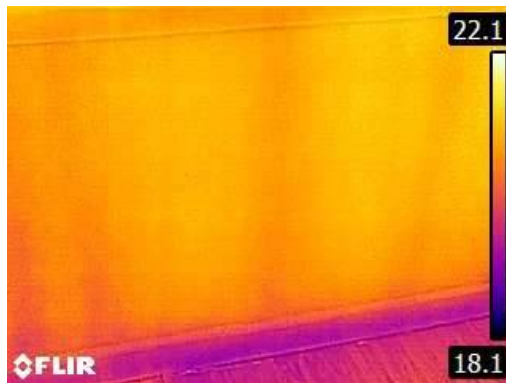
Photo 95-6 Very dry - no active moisture

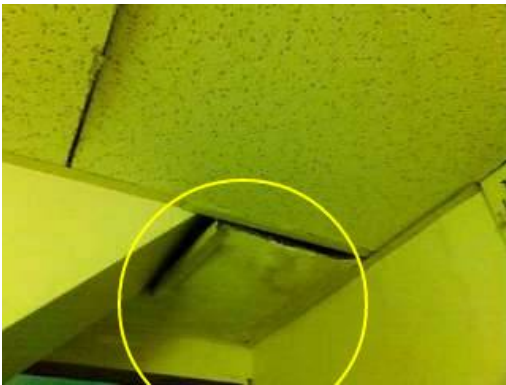
Photo 95-9 Water stain on ceiling tile is from an old leak

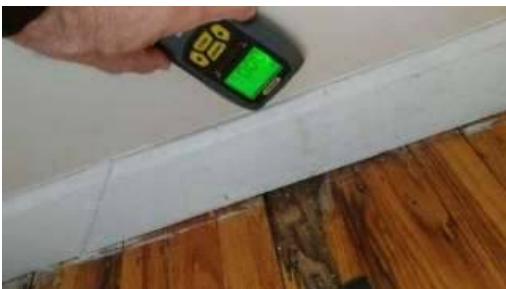
96) A section of flooring was rotted and according to homeowner it was an old leak. No signs of leaking water were currently present. Inspector checked it with a moisture meter and Infrared Imaging

Photo 96-3 Very Dry - no active water

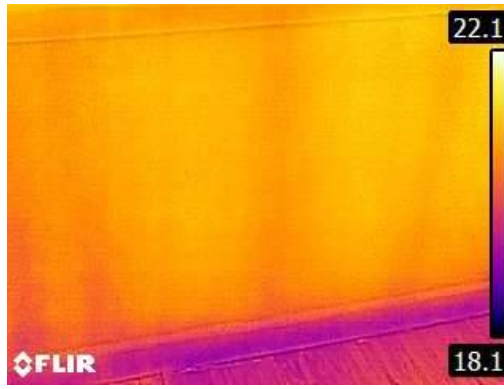
Photo 96-6 Very dry - no active moisture
